Technical Report ARCCD-TR-96003

**STUDY OF M831A1 OBTURATOR BAND ASSEMBLY,  
PROBLEMS, AND SOLUTIONS**

May 1996

**U.S. ARMY ARMAMENT RESEARCH, DEVELOPMENT AND  
ENGINEERING CENTER**

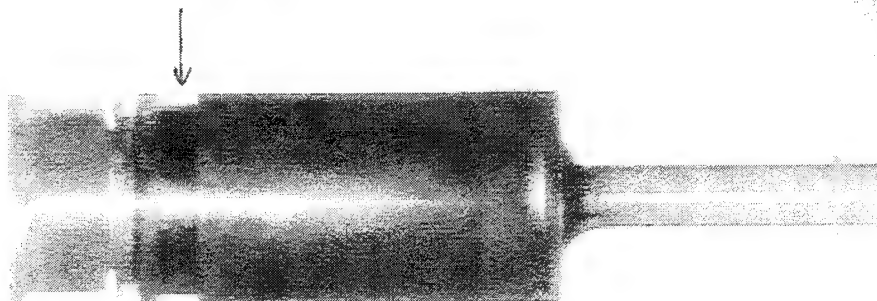
Figure 3  
M831A1 in-flight projectile

The in-flight projectile (fig. 3) consists of a spike, body (the spike and body together are called the projectile head), seal, ring, and stabilizer. The obturator is located on the body and is assembled in a groove, which is machined on the aft of the body.

In-flight projectile with obturator

In-flight projectile with discarded obturator

Several thousand M831A1 cartridges were fired during development, TC, and MR testing. Data on obturator performance for each of these tests were gathered and analyzed. In-flight obturator performance is shown for each round by either smear or hadland photos (fig. 3). These photos are stop action photos taken several feet from the gun muzzle which clearly show the obturator. The obturators are either still on the projectile or separating from the projectile as the projectile leaves the gun, as witnessed by the photos. It was determined that about half the time the obturators stay on the projectile during flight and half the time the obturators come off. When the obturator came off, it either broke into several pieces or broke in one place and came off as a ribbon. It was also shown that once the obturator came out of the obturator seat, it broke and did not hang up on the projectile.
